International Conference on "Water, Environment and Climate Change: Knowledge Sharing and Partnership" 10-12 April, 2018, Kathmandu, Nepal

Temporal and Spatial Variation in Water Quality of Bagmati River

Binod Chhetri Bhandari & Pramina Nakarmi Environment and Public Health Organization (ENPHO) Email: binod.bhandari@enpho.org

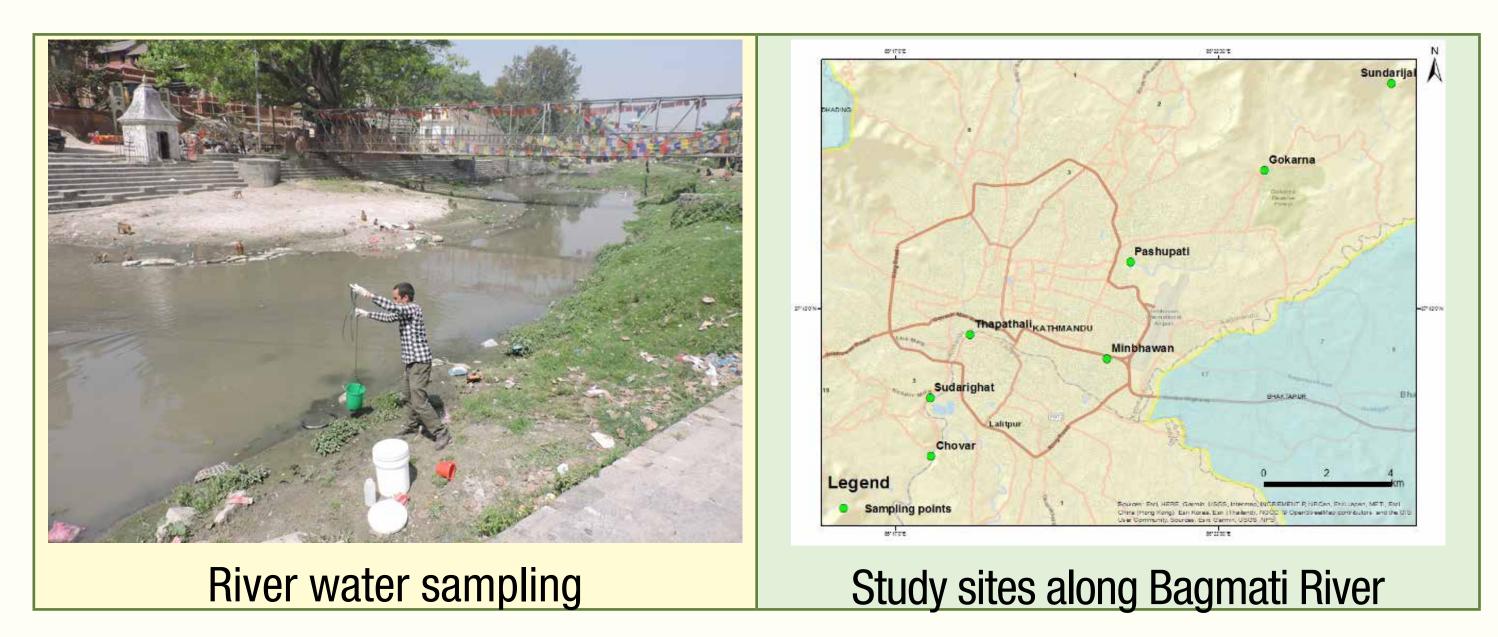
Study includes 7 different sites (shown in figure) along the stretch of Bagmati River representing different landscapes, mixing of polluted tributaries and population densities. These sites were tested for 9 water quality parameters during pre, post and during monsoon seasons from 2011-2014 for studying temporal and spatial changes in water quality.

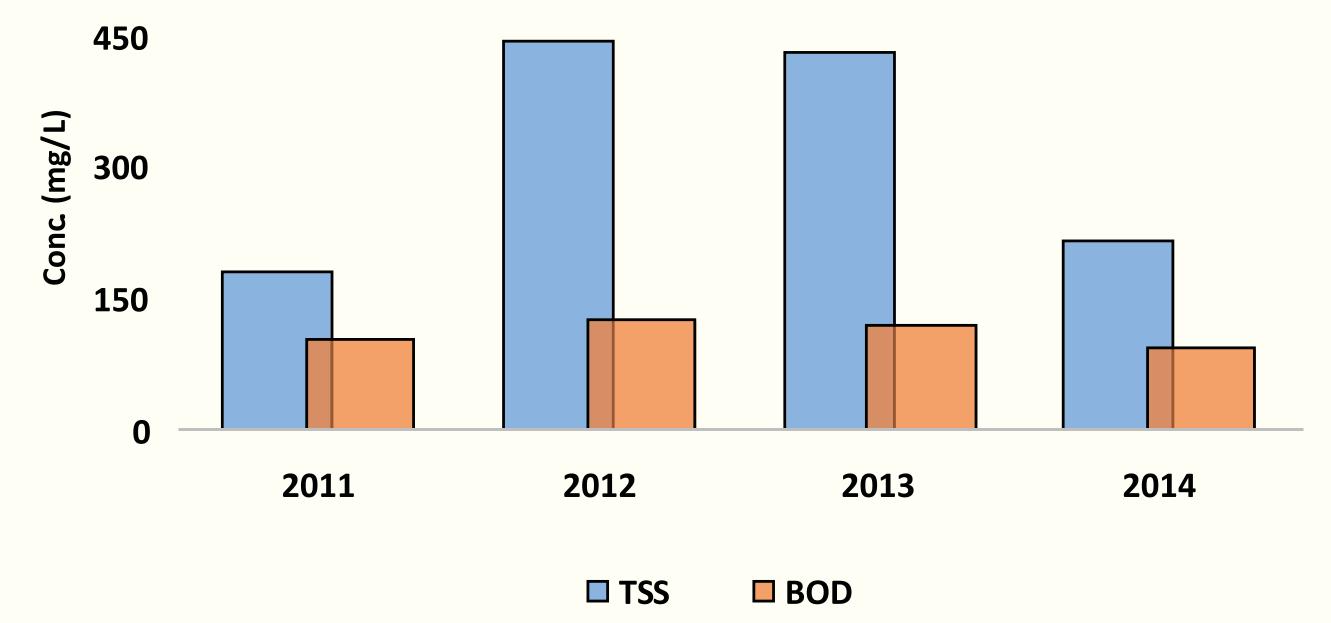
Yearly averages of TSS and BOD from 2011-2014

- Statistically significant annual variations were not observed in tested parameters.
- Values for TSS and BOD increased from 2011-2012 but dipped down in 2013 and further in 2014 which possibly could be attributed to cleaning efforts made through "Bagmati River Clean-up" campaign in May, 2013.

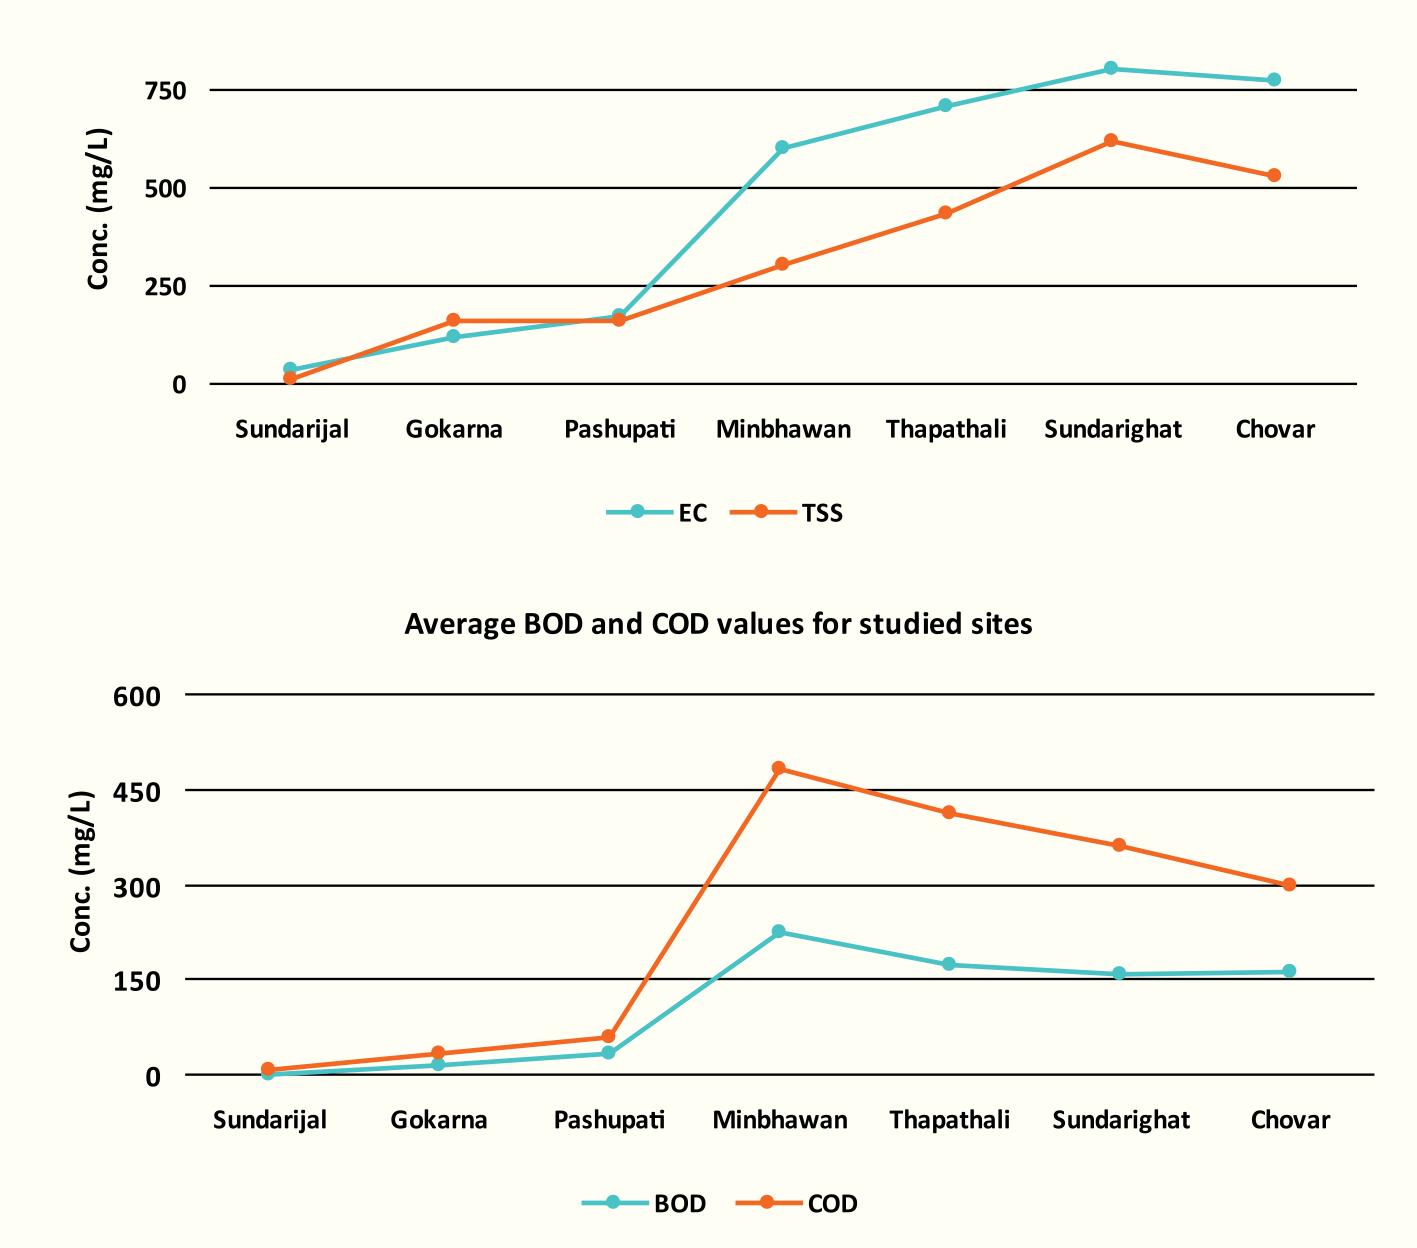
Average EC and TSS values for studied sites

- General trend indicates rise of contaminants level from upstream (Sundarijal) to downstream (Sundarighat) stretch of the river.
- Steep rise is consistent at Minbhawan for most tested parameters indicating a rapid increase in pollution at this site which can be due to direct dumping of untreated waste, remains of funeral pyres and ashes, bathing, washing, sewage etc.
