DEWATS FOR SANO KHOKANA COMMUNITY

Sano Khokana, Lalitpur, NEPAL

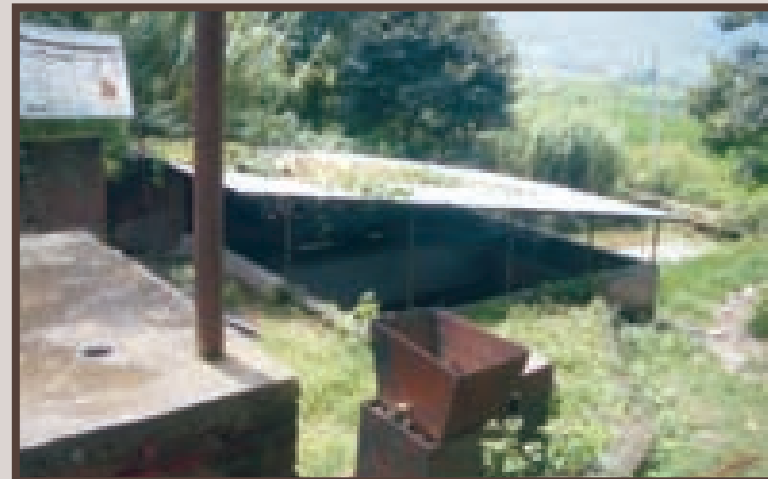
Modules Adopted

Biogas -1 Unit	
Type:	Fixed Dome – GGC
Biogas Volume:	20m ³
ABR – 1 Unit	
Area Construction:	9m ²
Chambers:	3 baffle walls
Depth:	2m average
Compost/ Sludge Pit: 2 Parallel Beds	
Surface Area:	25m ² each
Depth:	1m average
Filter Material:	None
Planted Gravel Filter: 1 Horizontal Bed	
Surface Area:	225m ²
Depth:	0.55m average
Filter Material:	Gravel
Plants Used:	Phragmites karka
Pond: 1 Polishing Pond	
Area:	50m ²
Built Up Area:	300m²

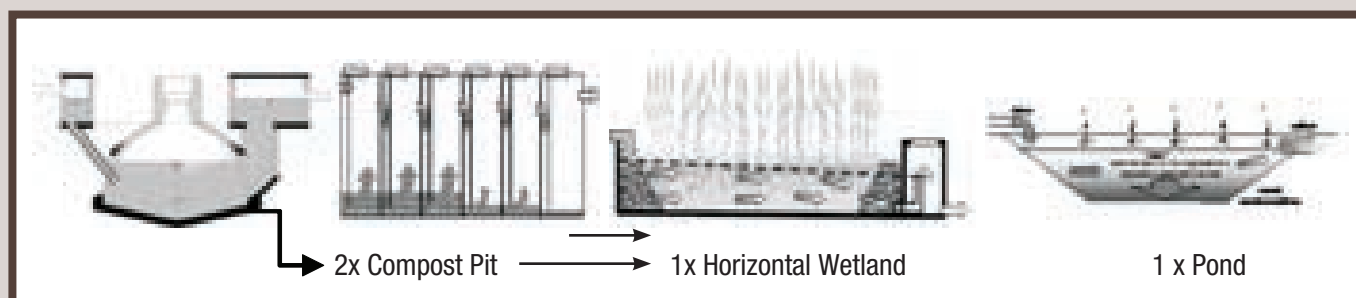
Typical Drawing of Components

All pit latrines connected to blackwater system and discharge into biogas digester. Greywater and stormwater diverted into channels and treated in baffled settler. Compost pits for sludge drying and horizontal reed bed and pond for final treatment of all wastewater prior to reuse for irrigation.

- Two grinders for waste and manure
- Biogas Plant for blackwater and waste
- Settler/ABR for greywater
- Two parallel compost pits for sludge/waste
- Horizontal flow wetland
- Pond
